Service Bulletin

NO.	353
MODEL	
	ECV860
DATE ISSUED	DATE REVISED
5/17

ECV860 Governor Response Improvement

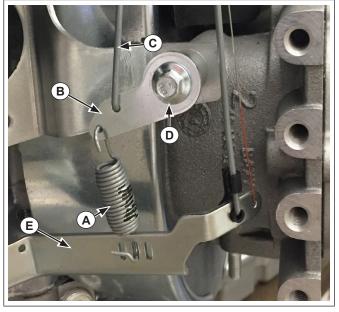
Figure 1. Original Governor Linkage Lever and Governor Spring.

There have been isolated reports of low power on the ECV860-3019 engine. It has been determined that the governor droop (reaction to load) is too slow on some of these engines.

Replacing the original (see Figure 1) black governor spring (19 089 08) with an orange governor spring 19 089 05-S and replacing the original governor linkage lever (19 090 01) with a new design (see Figure 2) governor linkage lever 19 090 05-S that moves the governor spring hole location, should correct this situation.

1. Remove the M6 screw (D) securing the governor linkage lever (B). Unhook the speed control linkage (C) and governor spring (A) from the governor linkage lever (B). Save the screw (D) and spacer behind the governor linkage lever (B); discard the governor linkage lever (B). Remove the governor spring (A) from the governor lever (E); discard the governor spring (A). See Figure 1.
