## Rough Running - Choke Linkage Interference

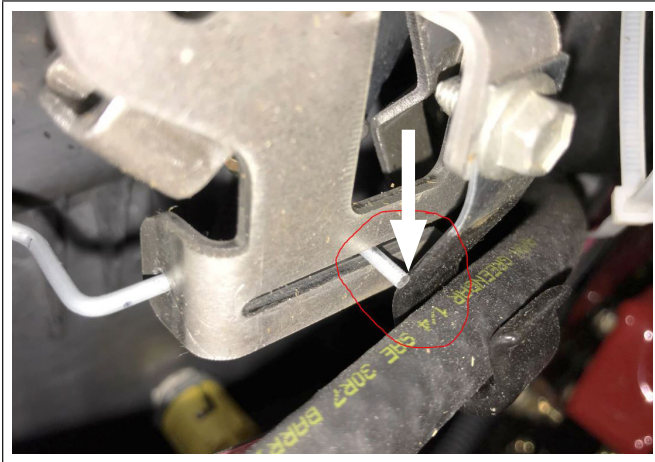
There have been isolated reports of KOHLER<sup>®</sup> 5400 Series engines running rough due to interference between the choke linkage and the fuel line J-clamp (see Figure 1). To correct the condition, reposition the J-clamp as shown (see Figure 2).

**Figure 1. Interference Between Choke Linkage and Fuel Line J-Clamp.**
