## 1000 - 1500 SERIES

<b>Part Numbers Affected:</b>	<b>618-05010, 918-05010, 618-05100, 918-05100.</b>
<b>Models Affected:</b>	<b>13xx93xxxxx (LTX and LGT Models).</b> (Models that begin with <b>13</b> and have <b>93</b> in the 5th and 6th position).
<b>Serial Number Range Affected:</b>	Model Year 2013 and 2014 (1A033H3xxxx through 1F054H3xxxx).
<b>Date:</b>	July 17, 2014/September 15, 2015 <b>Revised June 22, 2016 (Destroy All Previous Copies).</b>
<b>Subject:</b>	<b><u>Tuff Torq K46 Hydrostatic Transmission Axle Seal Oil Leak</u></b>

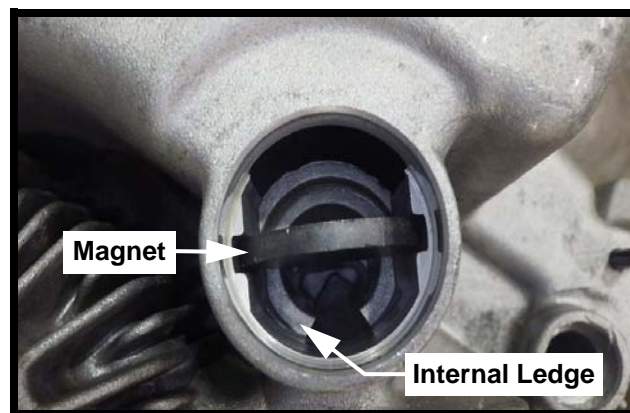
**FIGURE 1**

**NOTE:** Oil level should be to the height of the internal ledge feature located below the magnet shown in Figure 1.

1. If you have any non-retailed inventory of Models Affected within the Serial Number Range Affected, then proceed to Step 7 and follow the procedure for **753-08294A** Seal Kit replacement.
2. If a Model Affected tractor within the Serial Number Range Affected is presented for service and exhibits an oil leak at an axle seal, then proceed to Step 3.
3. Check the transmission oil level and fill as needed with SAE 10W-30 Class CD oil.
