## Engine Stall

The potential exists for these engines to stall for no apparent reason. This issue is limited to KOHLER® 7000 Series engines within the serial number range of **45327xxxx through 4613302464**. Not all engines in this serial range will exhibit the condition.

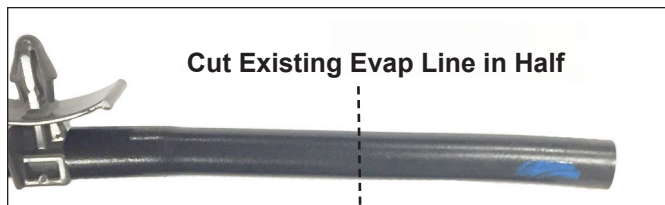
**Figure 1. Cut Existing Evap Line in Half.**

1. To access the evap line, remove the air cleaner cover, air cleaner element, and air cleaner base.
2. Locate the existing evap line (as shown in Figure 1), remove it from the purge port nipple on the carburetor, and cut it in half.

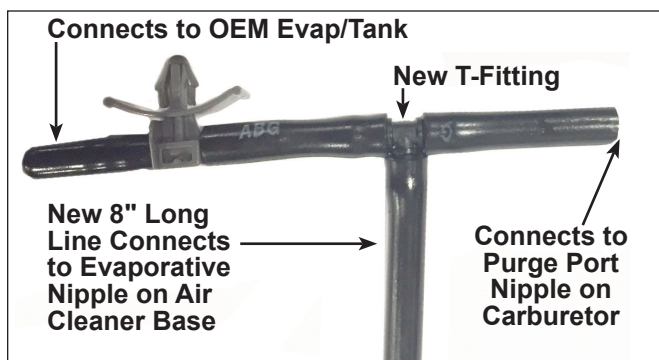
**Figure 2. New T-Fitting and New Line Assembly.**

3. Install the new T-Fitting at the location of the cut line. Take the new 25 326 28-S 14" long line and cut it to an 8" length. Install and route the new 8" long line as shown in Figure 2.

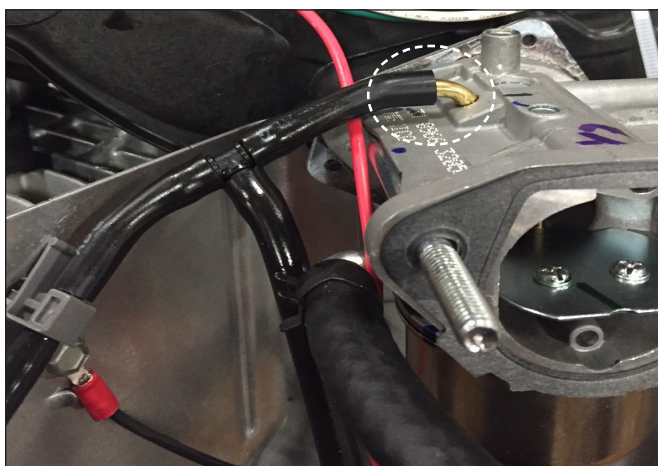
**Figure 3. New T-Fitting/Line Assembly Installed.**

4. New T-Fitting and line assembly is shown installed on the engine in Figure 3.

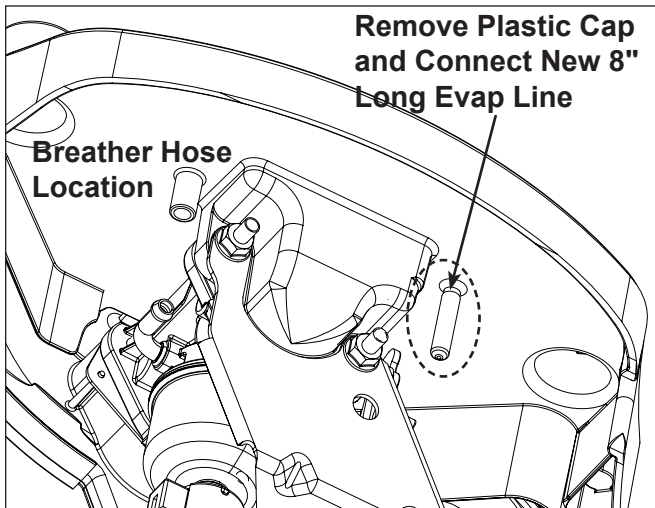
**Figure 4. Connect New 8" Long Evap Line to Air Cleaner Base.**

5. Route the new 8" long evap line from the T-Fitting to the plugged port on the air cleaner base. Remove and discard the plastic cap at that location. See Figure 4.
