### Fuel Hose Abrasion

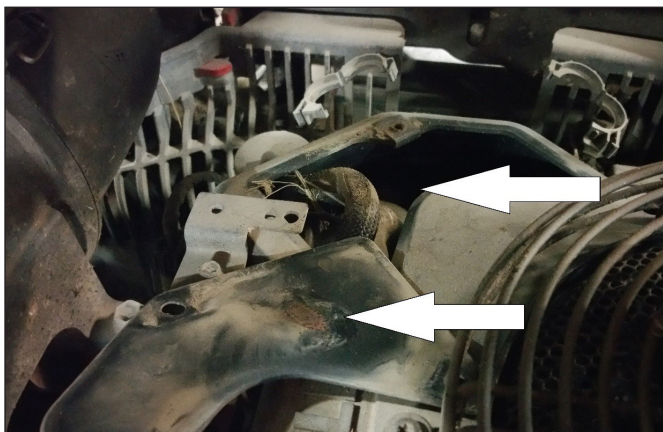
Figure 1.

Engines listed have the potential for fuel hose abrasion at the #1 cylinder where the fuel hose contacts the access cover (see Figure 1). Hoses exhibiting abrasion require replacement. A modified access cover is available to prevent abrasion (see Figure 2).

- A. If the abrasion sleeve is not worn through and the fuel hose exhibits no wear from contact, simply replace the access cover only. **Order and install access cover 24 096 168-S.**
- B. If the abrasion sleeve is worn through exposing the fuel hose (see Figure 1), the fuel hose assembly AND the access cover both require replacement. **Order and install fuel hose 24 399 31-S and access cover 24 096 168-S.**
