SERVICE UPDATE SEMINAR
2016-2017

KOHLER Engines

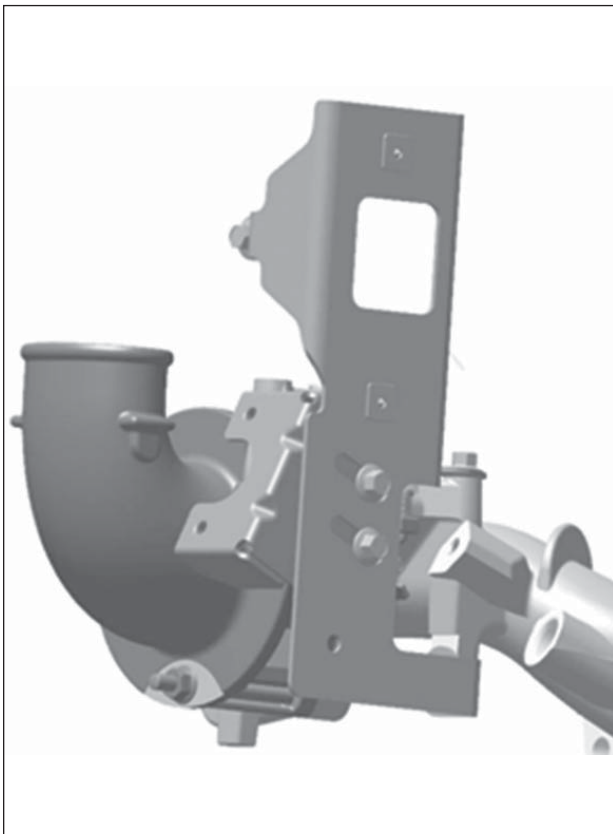
Old Version

Service Bulletin 345 described the significant changes implemented for Model Year 2016, electronic governor equipped, 999cc engines. These changes improve reliability by reducing vibration and addressing fatigue/wear on critical components.

- **Redesigned bracket for electronic governor system.**
Fourth leg added for stability.
Extra mounting bolt added to Digital Linear Actuator (DLA) bracket for increased rigidity.
- **Improvements to the DLA.**
High performance grease applied internally that will not migrate or evaporate.
Larger ball bearing to improve resistance to vibration induced damage.
- **Rerouting of wires, harness, and the addition of shrink tubing to address stress on the wire connections.**
- **Improvements to Governor Control Unit (GCU).**
Redesigned housing to prevent breakage of mounting ears.
Gold terminals for increases connectivity.
Adhesive used to secure wiring harness to GCU to prevent wear of terminals.

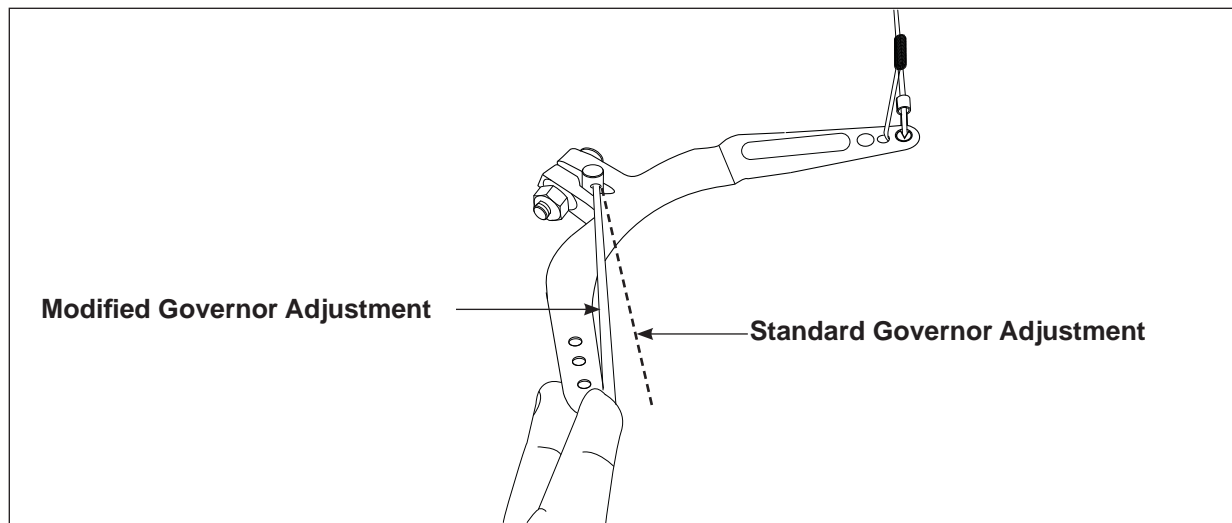
Remember, there are many possible causes of an engine surge. Specifically, run quality faults that are not caused by governor components/adjustments.

The modified governor adjustment illustrated below may resolve the surge. Testing suggests this may resolve surging conditions on older engines as well.

1. Loosen fastener.
2. Turn governor shaft counterclockwise to stop.
3. Secure fastener.

1. Loosen fastener.
2. Turn governor shaft counterclockwise to stop.
3. Slightly back off stop.
4. Secure fastener.
5. If surge persists, make incremental adjustments in the same manner.
6. If/When speed becomes uncontrollable, adjustment has been backed off too far.
7. If ineffective, return to standard governor adjustment.
8. Check speed setting and adjust as necessary.

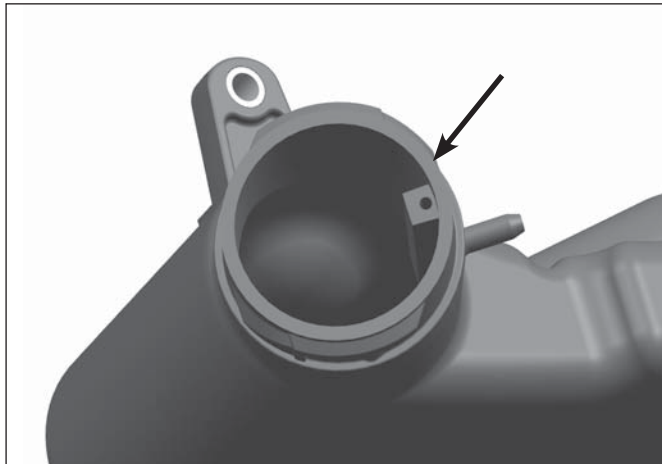
Original Tank 14 065 56-S.

The original tank (14 065 56-S) is the only one that should be replaced. It has been discovered, that incorrect fuel tanks are being replaced.

We have identified the engine specifications for which fuel tank (14 065 56-S) was originally installed.

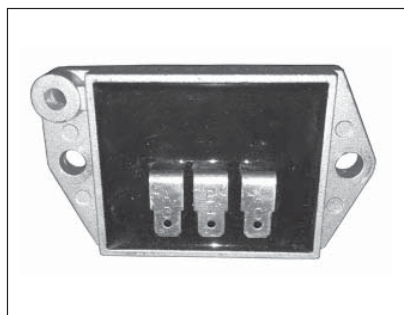
Figure 1.

This latest rectifier-regulator (see Figure 1), has a ground lug and built-in over-voltage protection that is self-resetting. The over-voltage protection prevents possible damage to other electrical components if an engine is jump-started. This regulator is especially recommended for use on EFI engines, **except** on Walker mowers where there is insufficient clearance for it to be used. When replacing an earlier regulator, like part number 25 403 05 (see Figure 2), just use the new regulator. To replace an older regulator (see Figure 3), use kit **24 755 144-S**, which includes the new regulator and the necessary conversion pieces.

The protective circuit in the new regulator works much like a circuit breaker. If excessive voltage is detected, the protective circuit breaks/opens the charging circuit (B+ output) to prevent the elevated voltage from reaching other components. Excessive voltage can be due to spikes caused by attaching or disconnecting jumper cables, or by loose battery terminal connections. It can also result from a defective battery that is not capable of holding a charge.

Once the circuit has been tripped, the circuit will discontinue charging for approximately 20 seconds. After 20 seconds the regulator will resume charging. If the over-voltage condition has not been corrected, the circuit will discontinue charging for another 20 seconds. This condition will repeat until the overcharge condition is corrected. Stop the engine. With the engine off, test voltage across the battery terminals. If it is below 12 volts, use an auxiliary charger to charge the battery.

When the battery has been charged, start the engine and test to confirm that charging output has been restored. Allow the engine to run for several minutes and test again. If the battery is defective, the B+ circuit will trip repeatedly until the faulty battery is replaced.

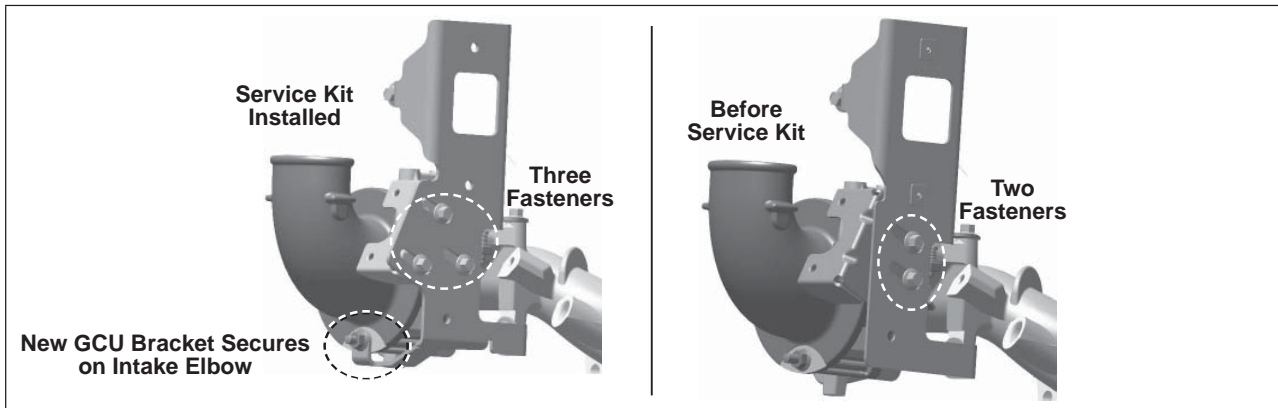
Figure 1. Identifying E-GOV Service Kit Components.

If the E-GOV update service kit has already been installed (as evidenced by Figure 1), and faults persist, this indicates the fault is not likely caused by the E-GOV system. Once the service kit has been installed, subsequent E-GOV system repairs will be performed with replacement components as needed, not another kit.

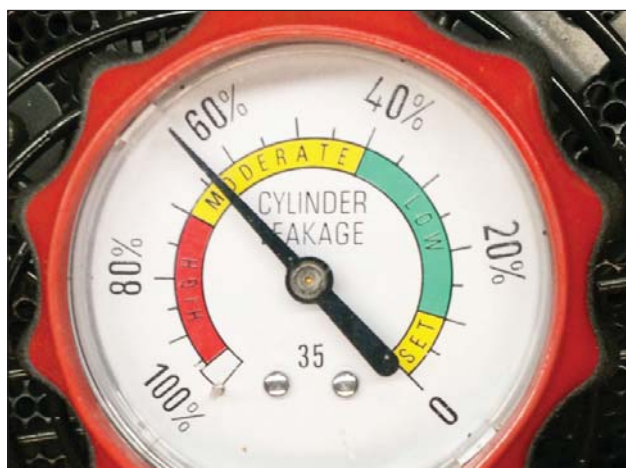
Because the current version of 25 761 05-S requires approximately 35 PSI to set/zero the gauge, this tool becomes less accurate when indicating high (red shaded) leakage. Numerous independent tests have identified 35 PSI can be insufficient for accurately measuring high amounts of leakage. This is more problematic on a single gauge tool where the incoming line pressure cannot be regulated precisely at 35 PSI. A tool utilizing an incoming line pressure of 75 PSI or more may indicate a passing leakage value on the same cylinder that fails utilizing a tool that relies on a lower incoming line pressure such as 35 PSI.

Figure 1. This should not be understood as having 60-70% leakage.

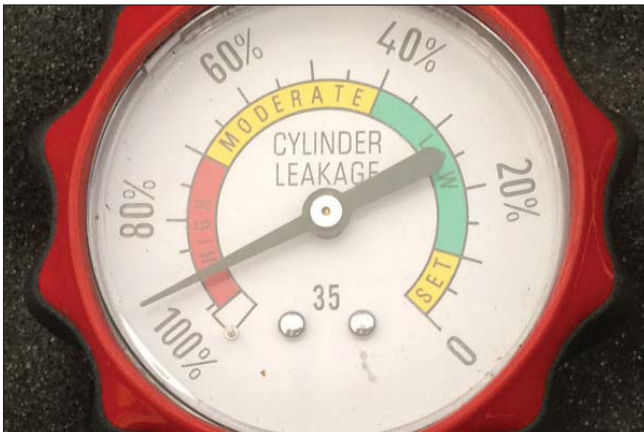
Figure 3.

Inspect the pressure gauges for faults, such as the needle not being in the proper position at rest (see Figure 3); this indicates a defective gauge that requires replacement. It is critical to release (by turning counterclockwise) regulator pressure every time the tool is used, as excess line pressure can damage the gauge.

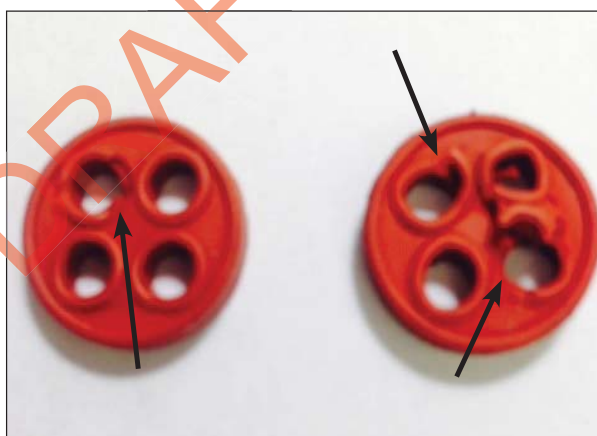
Figure 1. Damaged Discs.
