Service Advisory

Troy-Bilt Lawn Tractors

MTD-148

Subject: Enhanced Charging Of The Battery During Mowing

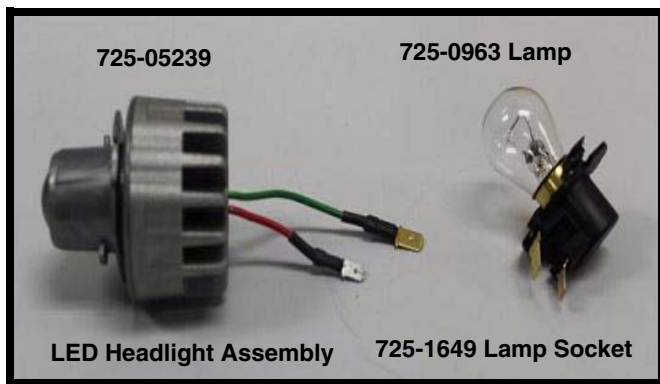
FIGURE 1

1. Raise hood and locate the left and right headlight assemblies located in the grille.
2. Unplug mower wire harness from each headlight assembly. (725-1649 Lamp Socket and 725-0963, Lamp Figure 1)
3. Twist headlight assembly counter-clockwise approximately 1/4 turn, remove and discard headlight assemblies.
4. Align tabs on LED Headlight assembly with mounting holes, twist LED Headlight clockwise until it locks in place.
5. Plug large connector from LED Headlight harness into large connector on mower wire harness.
6. Plug small connector from LED Headlight harness into small connector on mower wire harness.
7. Start engine and verify operation of LED Headlights.
8. Apply label 777125154 to the left leg of headlight harness as shown in Figure 2.
