SERVICE UPDATE SEMINAR
2016-2017

KOHLER Engines

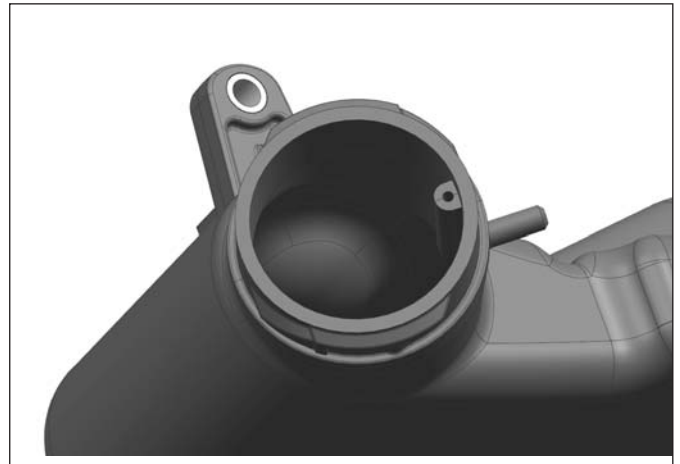
New Tank 14 065 63-S.

The original tank (14 065 56-S) is the only one that should be replaced. It has been discovered, that incorrect fuel tanks are being replaced.

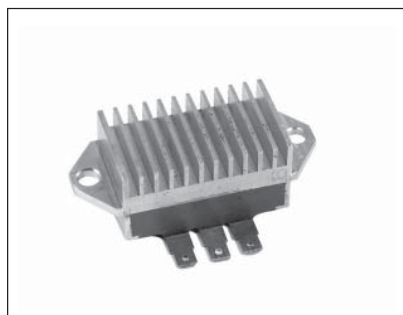
Figure 2.

This latest rectifier-regulator (see Figure 1), has a ground lug and built-in over-voltage protection that is self-resetting. The over-voltage protection prevents possible damage to other electrical components if an engine is jump-started. This regulator is especially recommended for use on EFI engines, **except** on Walker mowers where there is insufficient clearance for it to be used. When replacing an earlier regulator, like part number 25 403 05 (see Figure 2), just use the new regulator. To replace an older regulator (see Figure 3), use kit **24 755 144-S**, which includes the new regulator and the necessary conversion pieces.

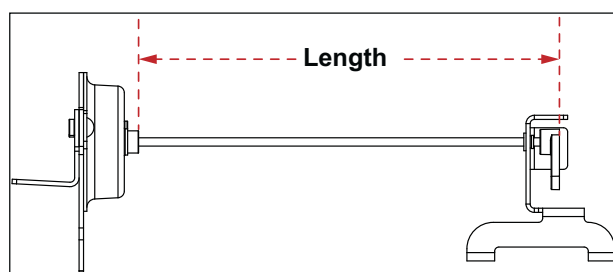
Figure 1. Length Reference Drawing.

1. Overall length of the assembly (rod). See Figure 1.
2. Position and design of the welded bracket on the thermostat housing for attaching to the muffler. See Figures 2 and 3.
3. Change to the outer support bracket that serves as a linkage stop.

NOTE: All references to length are measured from the bushing on the thermostat housing end, to the end of the shaft. See Figure 1.

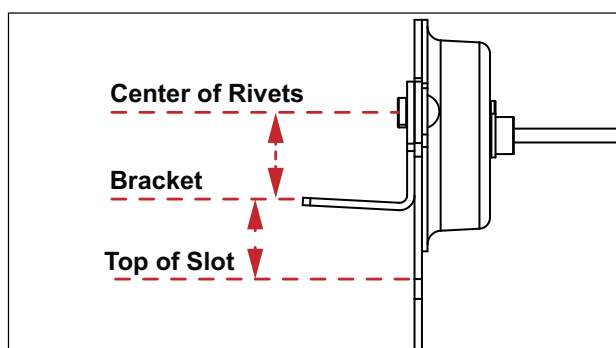
Figure 2. Bracket Position for Small Muffler.

The welded bracket position on the thermostat housing, illustrated in Figures 2 and 3, is based on the muffler size.

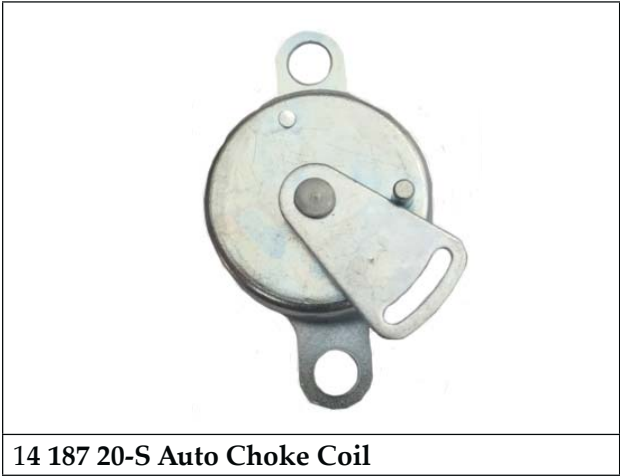
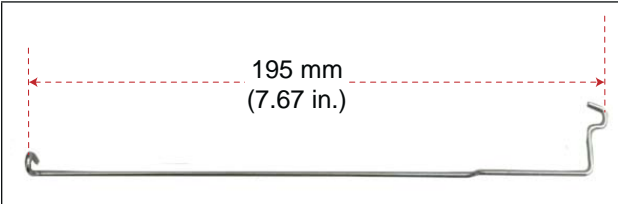
14 079 32-S Linkage

Push/Pull with Top Mounted Thermostat Design 2014 and Newer

This design consists of a thermostatic coil with lever, mounted on TOP of the muffler and moves a formed link (rod), which is pushed/pulled to actuate the choke. Two different length links were used depending on the engine involved.

- Used on XT650, XT675 engines.

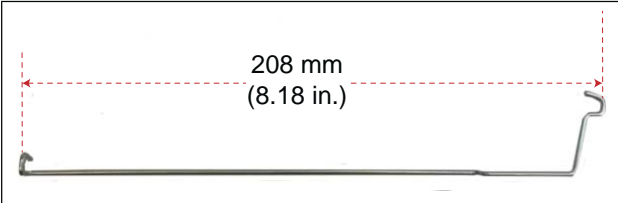
14 079 33-S Linkage

- Used on XT775, XT8 engines.

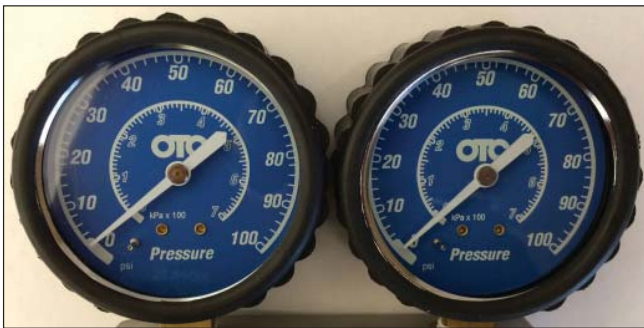
Figure 2. Dual Gauge Leakdown Test Tool.

Dual gauge leakdown tools (see Figure 2) utilize one gauge to precisely regulate incoming line pressure and a second gauge to observe pressure differential created by cylinder leakage. Ideally, both gauges will be identical and read up to 100 PSI. This tool provides the ability to precisely regulate incoming line pressure while identifying an accurate percentage of leakdown. For example, with 100 PSI of incoming line pressure indicated on one gauge and 80 PSI indicated on the second gauge, 20% leakage can easily be calculated. Additionally, the incoming line pressure can be precisely regulated as needed. For example, with 80 PSI of incoming line pressure indicated, and 40 PSI indicated on the second gauge, 50% leakage is calculated.

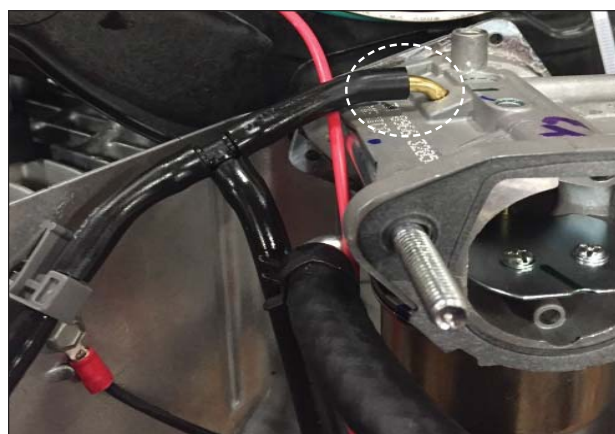
Figure 3. New T-Fitting/Line Assembly Installed.

4. New T-Fitting and line assembly is shown installed on the engine in Figure 3.

3. Install the new T-Fitting at the location of the cut line. Take the new 25 326 28-S 14" long line and cut it to an 8" length. Install and route the new 8" long line as shown in Figure 2.
