**Part Number Affected:** 726-3046 Ratchet Fastener

**Models Affected:** All Twin and Triple Baggers On All Platforms.

**Subject:** Replacement Of 726-3046 Ratchet Fastener On Bagger

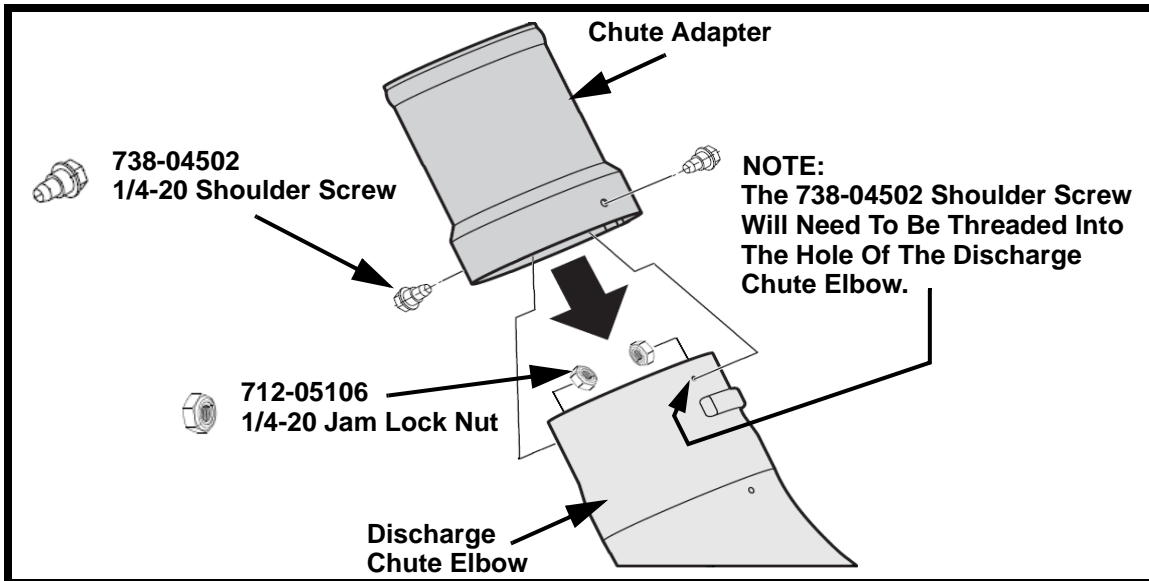
**FIGURE 1**

We have received reports that the **726-3046** ratchet fastener may become loose and fall out. This can cause the upper chute assembly to become disconnected from the discharge chute elbow.

2. Install the **738-04502** 1/4-20 shoulder screws from the outside of the chute adapter and securely tighten with the **712-05106** 1/4-20 jam lock nuts on the inside of the discharge chute elbow. See Figure 1.
