XT2 ENDURO SERIES

Affected Model: 13A9A1CS010

Date: March 30, 2016

Subject: Possible Loose EFI Connector at the EFI Module (ECU)

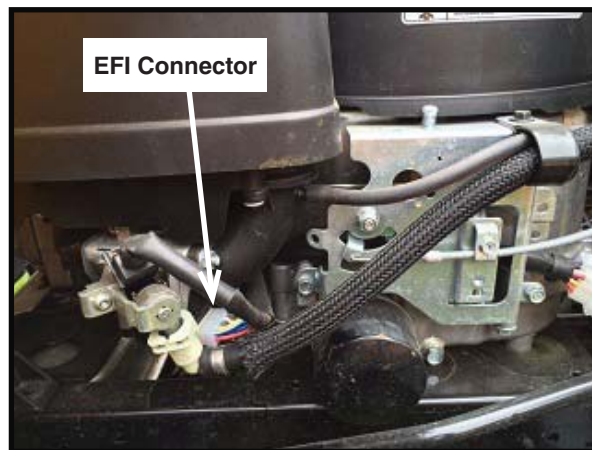
Figure 1

Purpose: A few of the main wiring harness connectors may have not been fully locked onto the ECU at the time of production on the above listed Affected Model, within the Affected S/N Range.

1. Inspect the EFI connector at the ECU, Figure 1, by gently tugging on the connector. If the connector remains attached to the ECU, no further action is required.
2. If the connector comes off, push it back onto the ECU until an audible click is heard, indicating that the locking tab on the connector is correctly seated onto the ECU. After clicked in, again gently tug on the connector to ensure a positive lock.
3. If a positive lock is not achieved, it may be necessary to secure the connector to the ECU with a zip-tie.
4. If using a zip-tie to secure the connector, be sure that the zip-tie does not pinch the wires at the connector.
